ONLY WITH  
**VIMAGO**  
SMALL ANIMAL CASE STUDY REVIEW

## HIGH-DEFINITION COMPUTED TOMOGRAPHY CASE REVIEW - L4-5: FRACTURE LUXATION

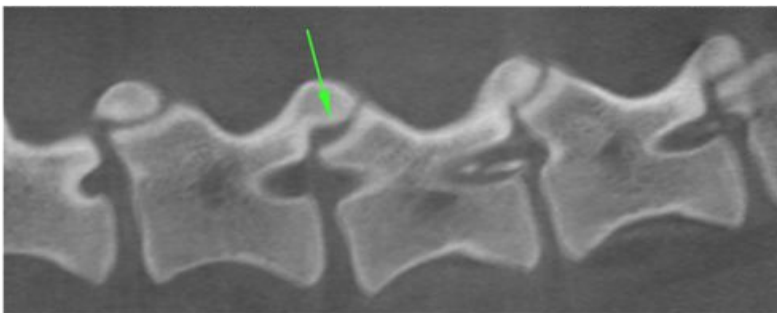
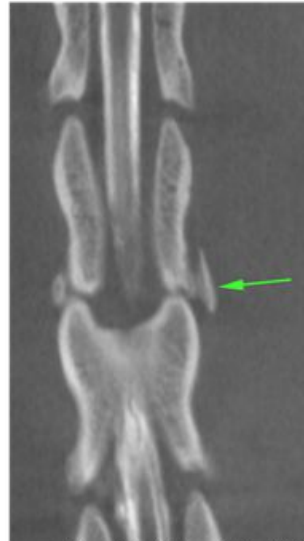
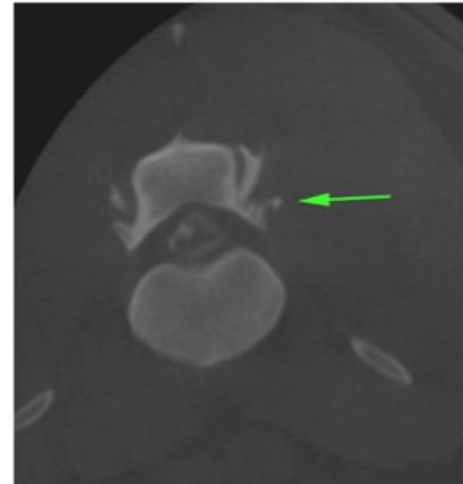
There was circumferential irregular spinal cord compression at the level of L4-5. This was complicated as this was the site of myelographic injection. A fracture of the left caudal articular process of L4 was seen on the MPR images (both transverse and dorsal plane images). Increased width of the joint space was seen in the left articular facet joint space and a mild step defect between the caudal end plate of L5 and the cranial endplate (ventrally subluxated) of L5 was seen.

L4-5: fracture luxation at L4-5. Probable spinal canal hemorrhage causing spinal cord compression.

Trauma is a major differential in acute neurology cases in dogs and cats. ***This case demonstrated the Vimago's™ ability to detect and characterize very small fracture fragments (not seen on MRI images in this case).***
